LAKE WALTER DAM

3 NDI I.D. PA-0080
DER I.D. 058-135
OWNER: MR. R. O. WALTER

7 PHASE I INSPECTION REPORT

6 NATIONAL DAM INSPECTION PROGRAM.

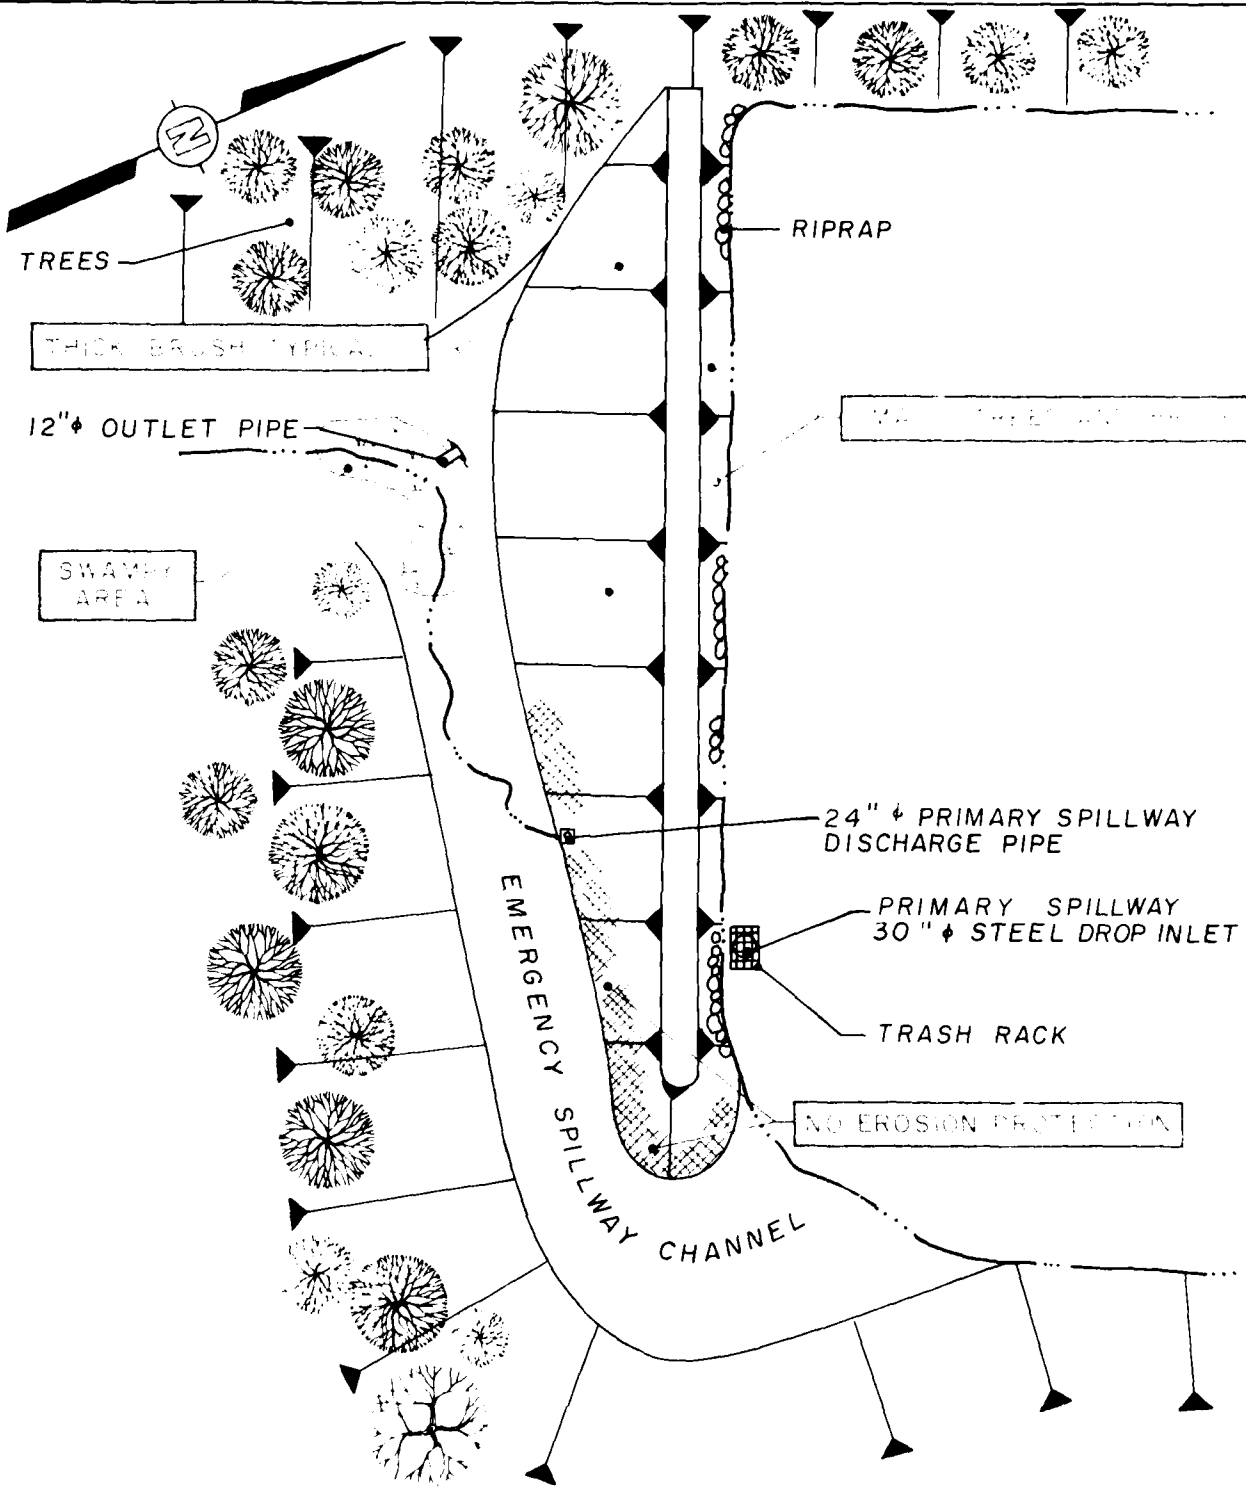
PLATE 5
 LAKE WALTER
 GENERAL PLAN
 FIELD INSPECTION NOTES
 FIELD INSPECTION DATE: NOV. 13, 1980

In general, the condition of the dam is considered to be good. One wet area was observed at the toe of the dam near the outlet pipe. No seepage flow appeared to be associated with this area. The downstream face of the dam was covered with thick brush which precluded adequate inspection of the dam.

VISUAL EXAMINATION OF	OBSERVATIONS	REMARKS OR RECOMMENDATIONS
JUNCTION OF EMBANKMENT AND ABUTMENT, SPILLWAY AND DAM	No signs of distress observed.	
ANY NOTICEABLE SEEPAGE	No measurable seepage was found. There is a wet area below the toe of the dam. See Plate 5 for location.	
STAFF GAGE AND RECORDER	None	
DRAINS	None
